Waterways Master Plan Staff Report on Recommendation #4c

On January 22, 2008 the County Commission received the Waterways Master Plan Report prepared by the University of Florida. As part of the Board's action on the many recommendations in the report was the request to have a report prepared by staff regarding recommendation 4c which stated "Study the effects that power loading of boats onto trailers may have on the structural integrity of boat ramps and determine if improved ramp design, or other strategies, can alleviate negative effects."

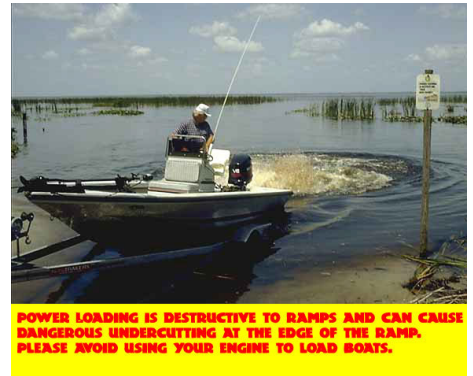
Power loading has caused many of the State's ramps to age prematurely. Early ramps were not built to handle the prop wash caused by power loading. Many ramps have been undermined by prop wash and collapsed. Also a sediment berm or delta is formed waterward of the ramp by power loaders and can block boater access to adjacent waters during low water periods. New ramp designs are utilized by the Commission to reduce damage caused by power loading. However, it is preferable not to race your engine while loading.

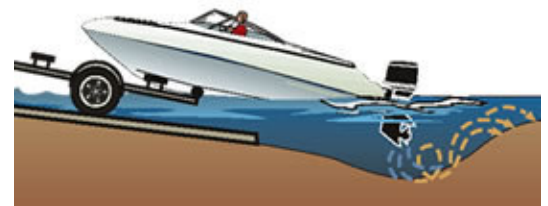
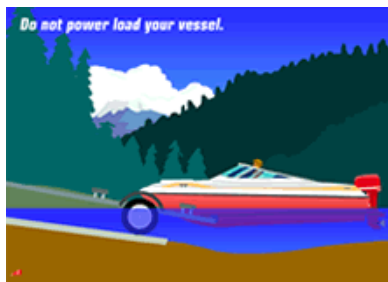
Do Not Power Load Your Boat

Propeller wash can erode the sediment just beyond the ramp surface, creating a large hole. The eroded sediment is deposited behind the propeller, creating a mound. Trailer tires can get stuck in these holes, and boats can run aground on the mound.
